## Habitat mapping - Höje å Group one

# Habitat Mapping of Höje å, Scania Sweden

# Habitat mapping and stream restoration

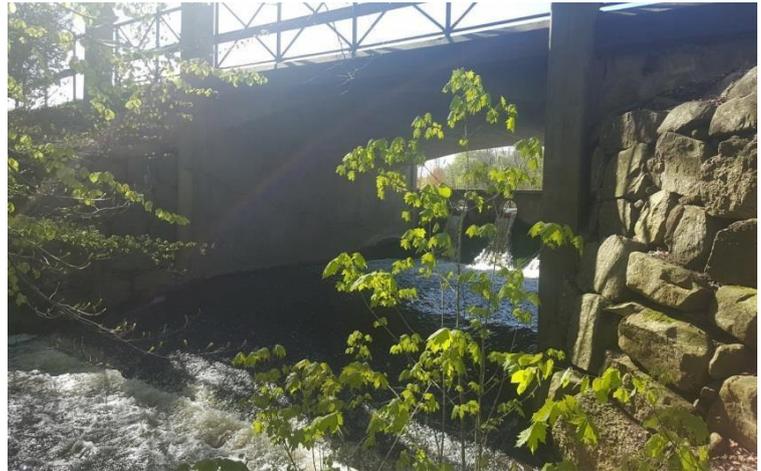
Figure 10. Beginning of the river and the first road pass in section one (L1).

At the beginning of the river (section one), a barrier with four culverts has been constructed and is right underneath the road (figure 10). The river is connected to the lake through this barrier and upon closer inspection (figure 11), the drop height was approximately 2m which might cause difficulties for the fishes to cross.

After the habitat mapping along *ca.* 2 km of *Höje å*, it can be suggested that some improvements can be done. Natural barriers that cause total blockage for fish passage should be taken away and some stones and pebbles should be artificially placed along the river to provide nursery habitats, spawning areas and resting spots.

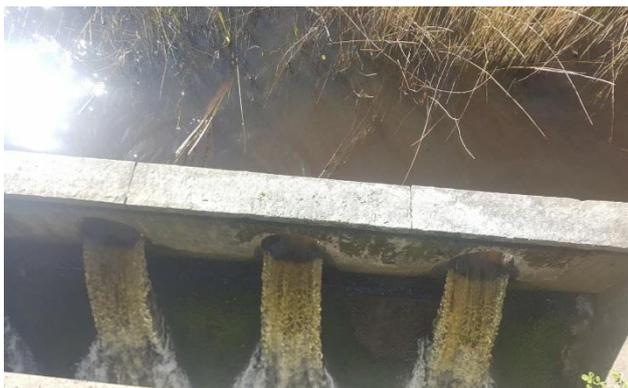
Figure 11. A close up of the culvert in section one.

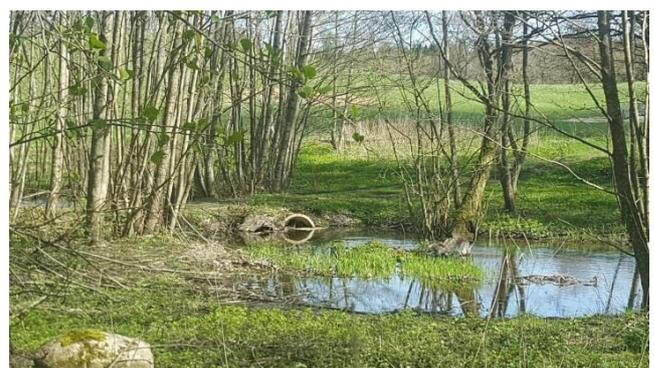
Further along the river (still section one) there was another constructed barrier to enable passage. This barrier had two culverts with a low drop height, high depth and large diameter allowing fish to cross easily (figure 12).

Figure 12. Picture showing the second road passing in section one (L1).

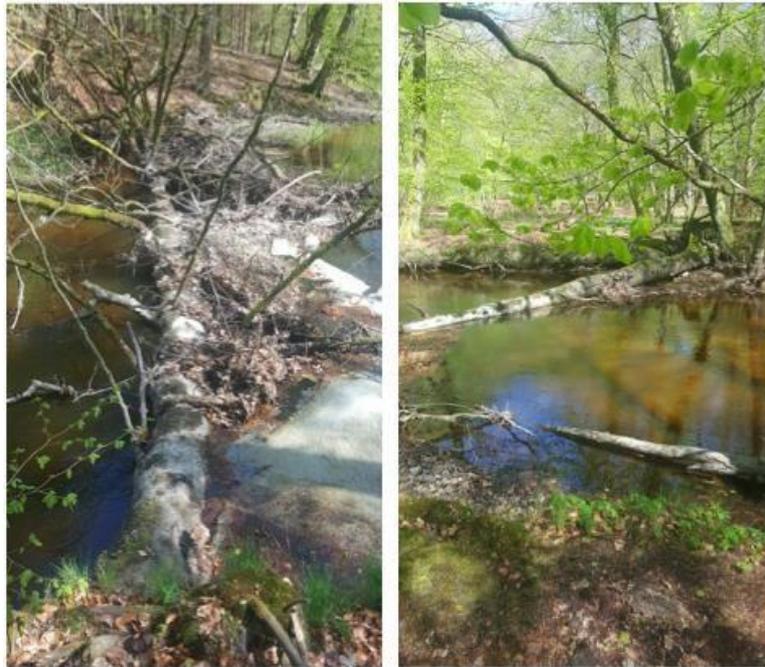
*Figure 13. Pictures showing two out of the four natural barriers in section two and three.*

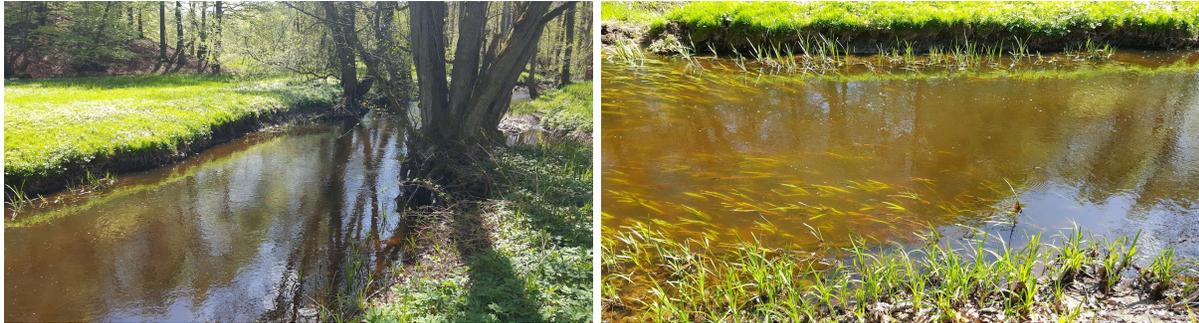
Figure 5. Images taken in the downstream (left) and the upstream parts of the river (right). The image on the left shows a lack of vegetation growing in the water as most of it was growing on the bank.

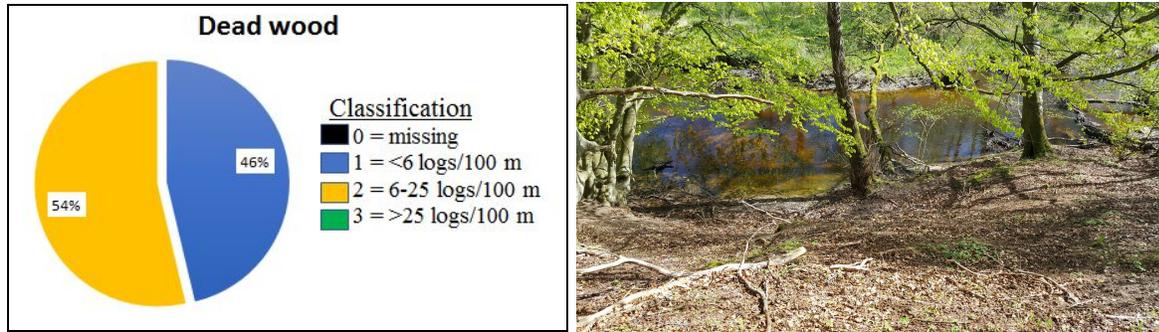
Figure 6. The percentage of the river that had a dead wood classification of 1 or 2 (left). An example of dead wood in the river in a photograph taken by one of the authors (right).

During our walk along the river, we saw a few pipes leaking water into the Høje å. We do not know the source of the water leaking through these pipes, perhaps it is water coming from nearby agricultural fields or maybe it is sewage water. If either of these cases are true, these pipes would prove to be a major source of nutrient intake to Høje å. Parts of the river stretch that we studied are located within the Hækkeberga nature reserve, meaning there are very few buildings or other human interferences, except for the cultivation of the nature reserve. There was a good amount of dead wood along the whole stretch indicating that there is a high biodiversity. However, if too much dead wood appears in the same spot, it may create a barrier to fish (Figure 6).

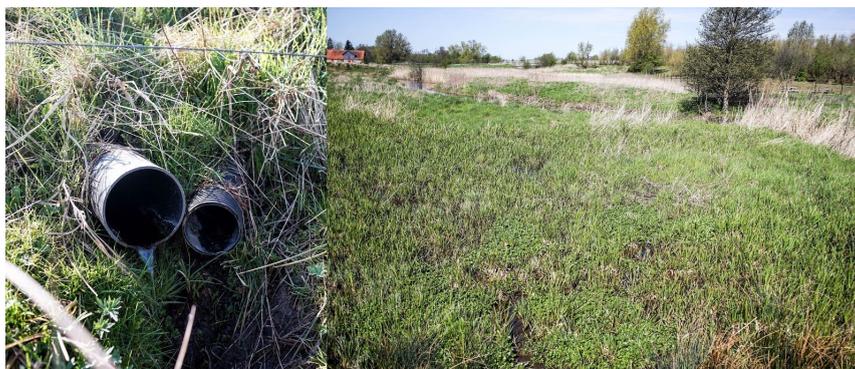
**Figure 2.** Example of drainage pipes (left) and flood plain (right) in vicinity to Høje å.

the water and lower the temperature of the water. Due to the large number of drainage pipes we observed and the intensively cultivated surroundings it could be assumed that the water from the pipes is a source of nutrients in to the river. Notable is that almost all the drainage pipes (except for one) poured out onto floodplains, where a large amount of nutrients could sediment. In this way the amount of nutrients the river receives is probably decreased compared to if the drainage pipes poured out directly into the river.
