## Habitat mapping - Höje å Group one

# Habitat Mapping of Höje å, Scania Sweden

# Habitat mapping and stream restoration

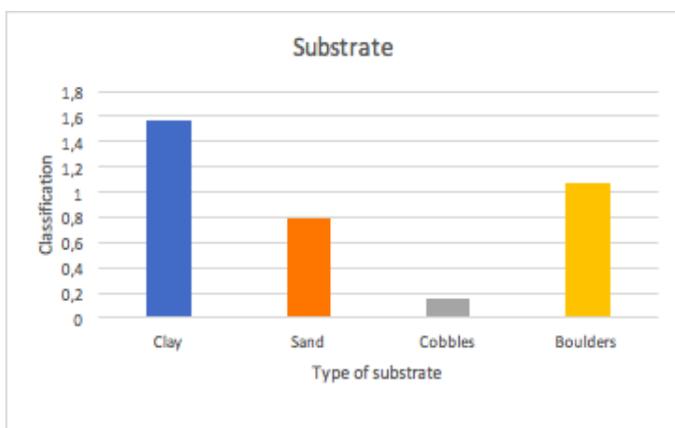
Along the *ca.* 2 km of the first part of the river, the main substrate is clay, see *figure 3*. Cobbles are mostly found in the first section of the river.

The result of just having mainly clay in most of the sections of the area is that there are not many nursery habitats or resting spots (rock beds) for different invertebrates or vertebrates. As *Höje å* is a meandering river one could assume the opposite. Also, with the presence of clay, the secchi depth is lower in most of the sections in the river that might influence in the presence or absence of vegetation in *Höje å*.

*Figure 3. Differences in the substrates among the surroundings of the river according to protocol A, where 3 is >50% and 0 is missing.*

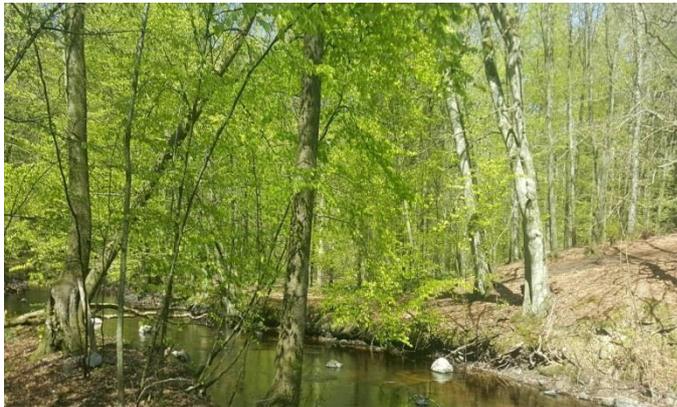
The data collected with the protocols show that this area of the river does not provide optimum nutrient sedimentation. However, a few wetlands were found at the end of the section where also the water had a slower flow, see *figure 7*.

Figure 7. Largest width of the river located in section two (L2) to four (R4). Also indicating that the surroundings at this part is young forest.

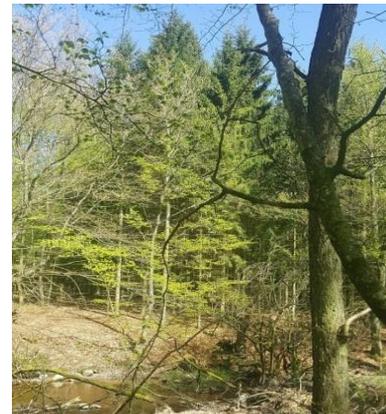
*Figures 5 and 6* indicate that the surrounding and ambient area consists mainly of deciduous and young forest, illustrated in *figure 7*, whereas coniferous forest is presented in a low percentage. The presence of mixed forest in section one (L1), two (R2), three (R3) and four (R4), see *figure 8*, might suggest that the diversity surrounding the stream is higher due to a combination of niches. Forests provide beneficial effects, one of them being the presence of dead wood that was observed in field.

Figure 8: Picture showing the surroundings in section two (R2) where one can clearly see that it is a mixed forest.

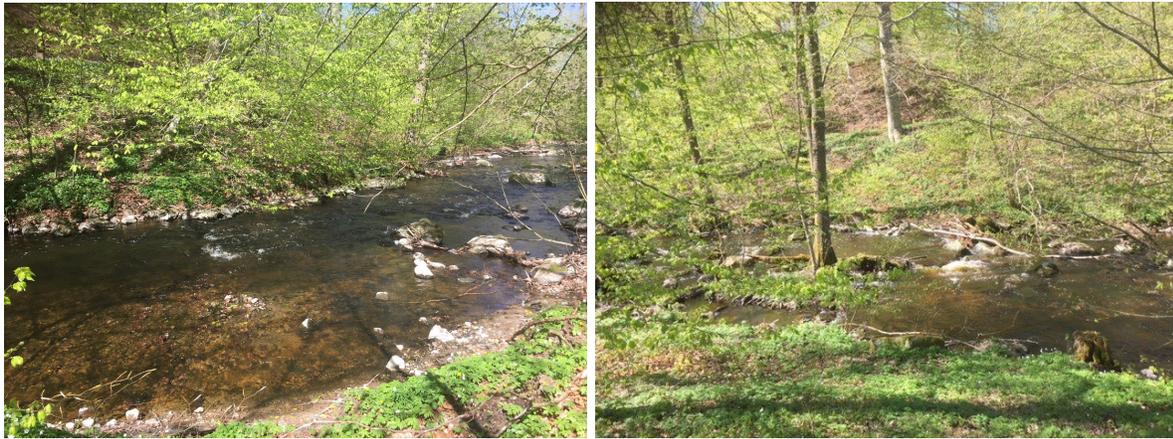
Figure 4. An example of a spawning site (left) and a nursing habitat (right) photographed by the authors during the excursion. Both pictures were taken in the beech forest blue zone (Figure 1).

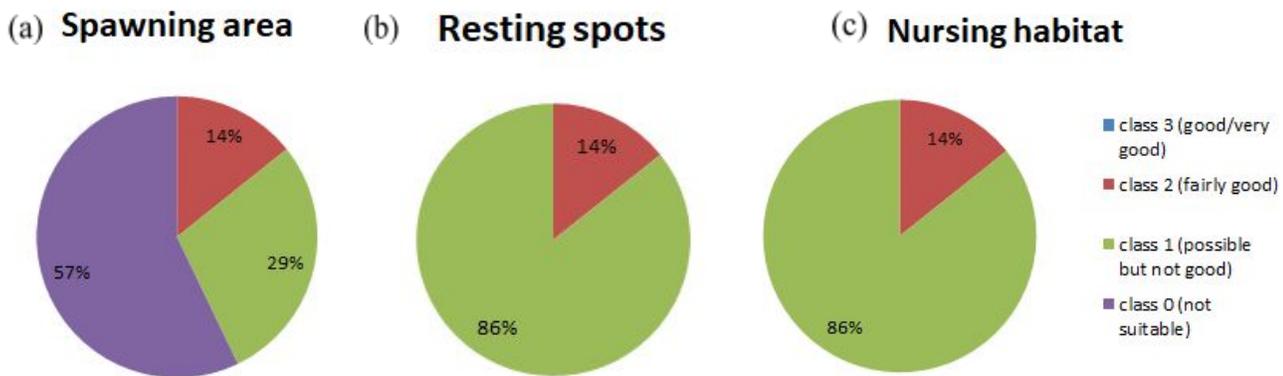
Other elements that are important to the trouts are ones that contribute to availability of protection against the current, places with leeward where they can rest. Examples of this type of element is boulders. In average 14 % of our part of the stream were fairly good as resting spots (class 2) (fig 2b). We had some areas that were rich in boulders, but the dominant substrate the whole stream through consisted of sand only which lead to that the other 86 % in average consisted of areas that were possible resting spots.

Good habitats for nursing consists of the same elements as areas for resting. This lead to that we got the same results of amount of nursing habitats as the amount of resting spots (fig 2c).

Figure 2. Suitable trout habitat based on sediment substrates. Class 0: absent/not suitable; class 1: possible but not good; class 2: fairly good; class 3: good/very good. (a) spawning area (b) resting spots and (c) nursing habitats.

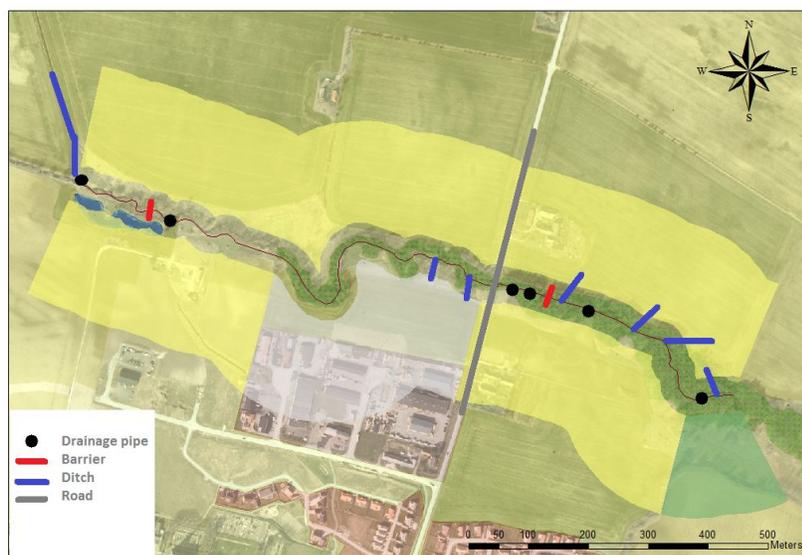
This stretch of river Høje is mostly surrounded by agricultural land, however there is also some urban areas and a smaller area with deciduous forest. There are several ditches and drainage pipes that lead away the water from the surrounding fields, and are entering the stream of Høje å from both sides (see figure 3). The first ditch encountered downstream is the longest and the widest, and flows between two major fields. The rest of the ditches in this stretch are small and shallow, they come from the sides of the fields and from wetter areas by the stream. The fields has an impact on the ditches and subsequently on Høje å as well. The drainage pipes enters the stream just at the shoreline.

Due to deadwood, there are some natural barriers in the stream. Smaller logs and branches has got stuck in the stream in several places and built up barriers. On two of these places the content has created a barrier that fish are not able to pass when it is low water. When the water is high the barrier is under the surface and is possible to pass.

Figure 3. Stretch of Høje å surrounded by agricultural land - yellow, urban area - grey, and forest - green, in the area from 30-200 m. Drainage pipes - black dots, barriers - red lines, ditches - blue lines, and roads over the stream - grey lines, is shown.

The surrounding/ambient environment is predominantly agricultural land with many ditches and pipes leading from the surrounding into the river, suggesting a considerable amount of nutrients entering the river (fig. 3). However, very little water vegetation and algae were observed contradicting this suggestion. Since the nutrient levels was not measured, no final conclusion can be drawn.

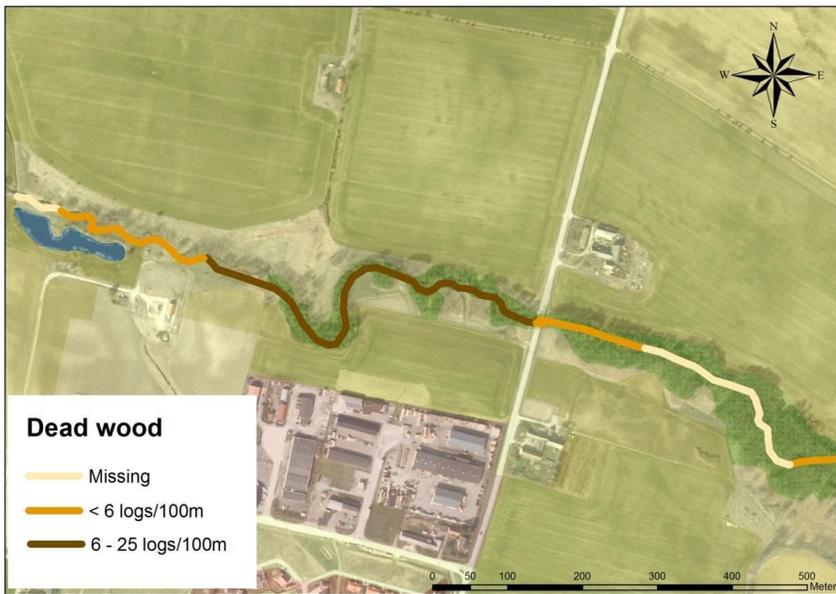
When a stream is surrounded by trees and shrubs, logs can fall in the water and become a habitat for water organisms. The amount of deadwood are varying along the stretch. From places where there are no logs, both downstream, with a length of 64 m, and upstream, with a length of 277 m, to where there are up to 25 logs/100 m, in the middle of the stretch, with a length of 599 m. Between them are stretches where there are up to 6 logs/100 m, with a total length of 447 m. See figure 5.

Figure 5. Map with the amount of dead wood in the water along the stretch of Høje å. Beige - missing, orange - <6 logs/100 m, brown - 6-25 logs/100 m.
